INDOOR AIR QUALITY ASSESSMENT

**Greenfield High School
1 Lenox Avenue
Greenfield, Massachusetts**

Prepared by:
Massachusetts Department of Public Health
Bureau of Environmental Health Assessment
August, 2000

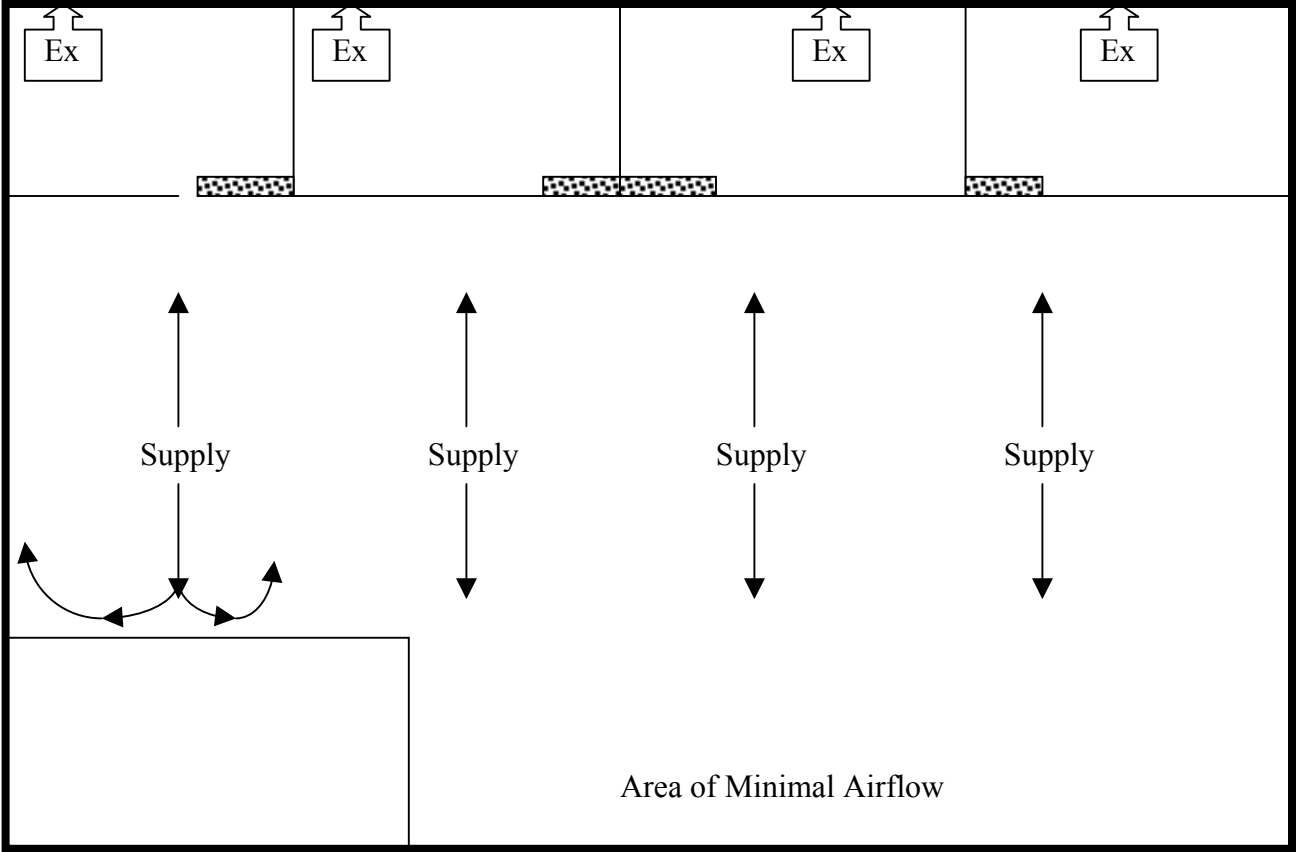
Figure 3

With functional exhaust ventilation, fresh air from the air diffusers will tend to be drawn back to the main offices, decreasing distribution to the former exterior wall (see Figure 3). This condition would lead to stagnant air in the former exterior wall side of the library. Further enhancing this effect is the existence of a skylight, which heats the air of the former exterior wall side of the library (see Picture 5). The combination of lack of airflow and heat from the skylight tends to make the outer half of the main library area uncomfortable. The wood shop also has a ceiling-mounted AHU (see Picture 6). It appears the fan motor was removed, rendering this AHU inoperable.

Example of Airflow with Library Private Office Doors Closed

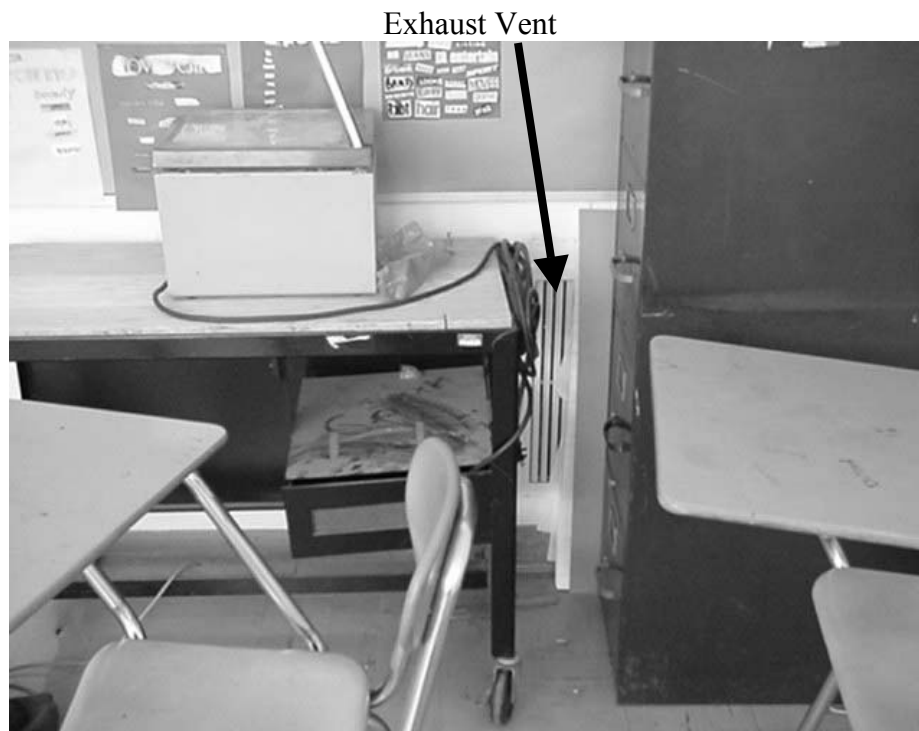
Picture 3

The mechanical exhaust ventilation system consists of wall-mounted exhaust vents. As with the univents, exhaust vents were obstructed by shelves, chairs, boxes and other items (see Picture 3). Without removal by the exhaust ventilation, normally occurring environmental pollutants can build up and lead to indoor air complaints. A number of vents were not operating, which can indicate that exhaust ventilation was turned off, or that rooftop motors were not functioning. BEHA staff examined exhaust motors on the roof and found a number of exhaust motors not operating.

Example of Blocked Exhaust Vent

7. Inspect exhaust motors and belts periodically for proper function; repair and replace as necessary.
8. Remove blockages of univent air diffusers, univent return vents and exhaust vents.

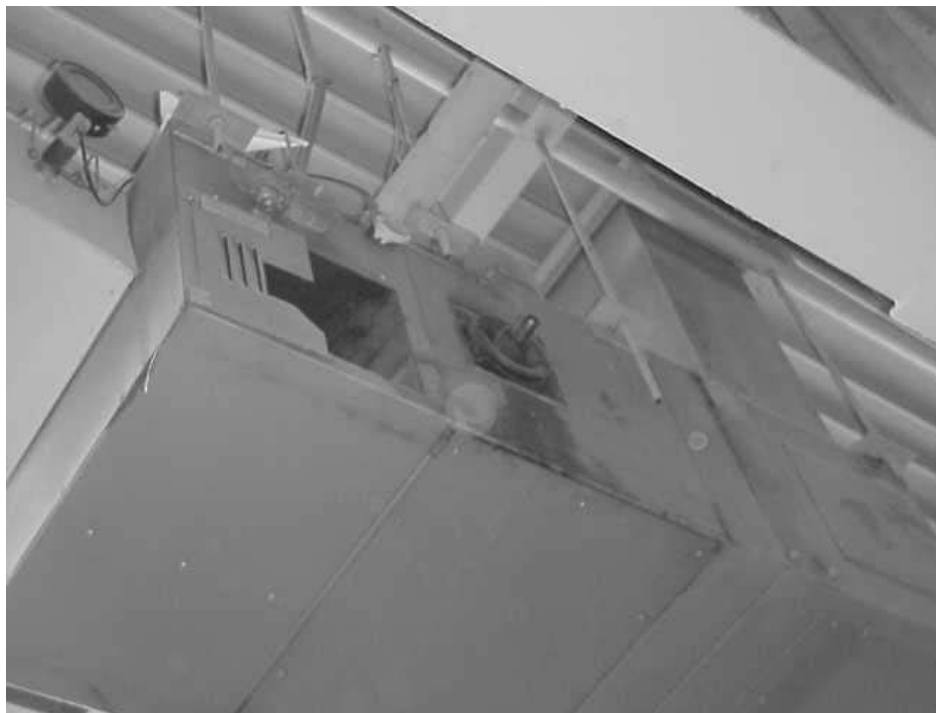
Picture 6

Missing Motor from Wood Shop AHU

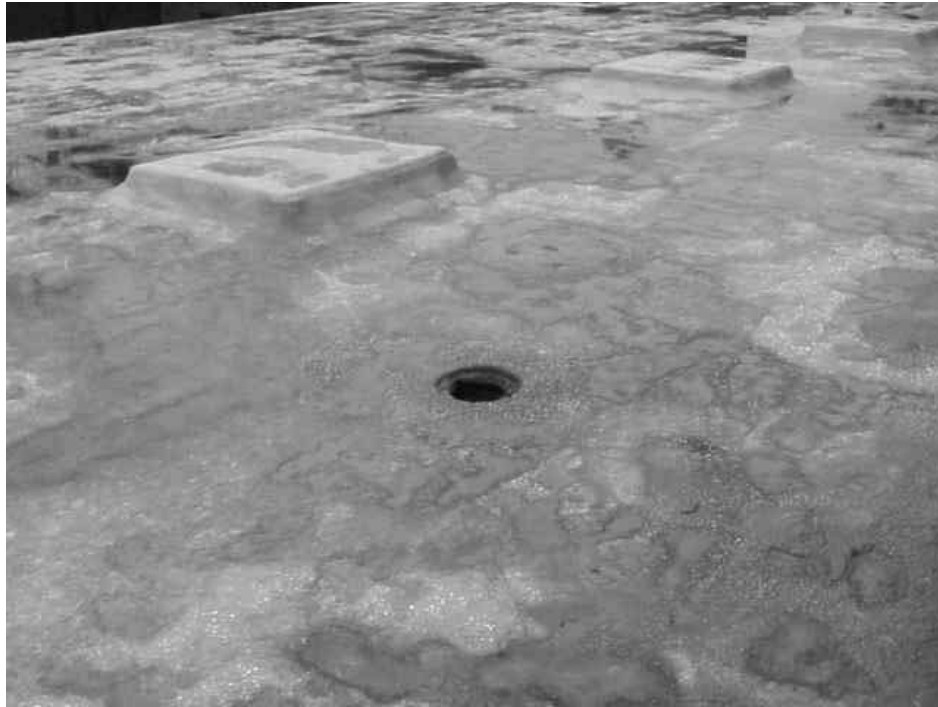
Picture 8

**Roof Drain Opening, Note Pooling Water in Troughs
That Do Not Direct Water to Drain**

1. Consider consulting a building engineer about possible options to eliminate water pooling on roof. Options to reduce water pooling may include: resealing over the existing roof or total roof replacement.

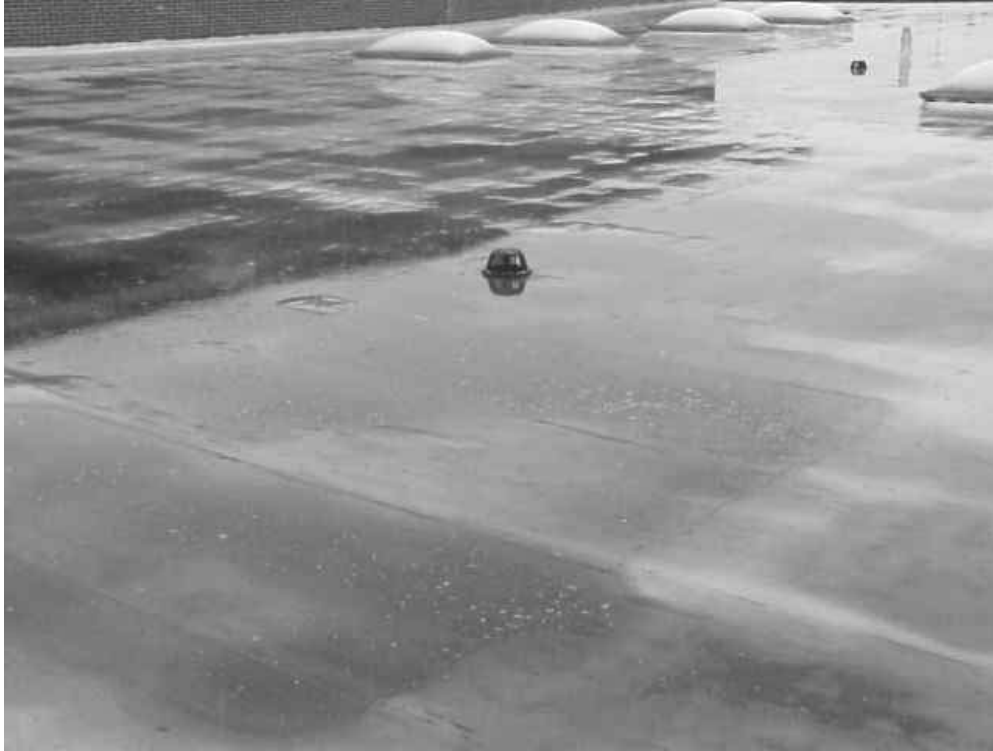
Picture 9

Repaired Section of Roof, Note Pooling Water Created by Troughs in Repaired Roof

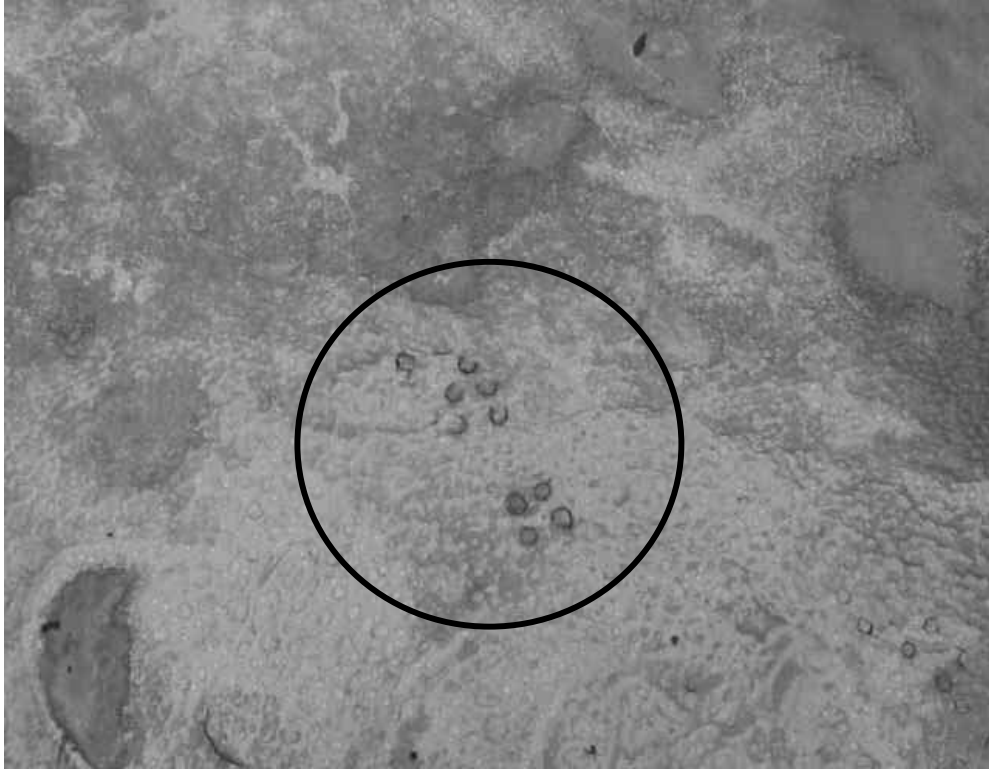
Picture 10

Damage to the roof exists in many areas. Since the surface of the roof is a spray on material, it would be expected to consist of a thin layer, which could render the roof more susceptible to mechanical damage. In one area, the roof has holes that were created

by an individual walking in cleated athletic shoes (see Picture 10). Numerous other cracks and holes in the outer coat were noted (see Picture 11). School officials attribute this damage to birds pecking at the roof. Birds can consume coarse gritty materials or stones that lodge in the gizzard to aid in digestion of food (Hickman, C.P, Hickman C.P., Hickman, F.M., 1978). While no birds were observed damaging the roof, deep, puncture holes were noted in many areas (see Picture 12). In one instance, a plant was found growing from a crack in the roof (see Picture 13). Each of these cracks, holes and other forms of penetration through the exterior coat of the roofing material can result in water penetration into the building envelope. As an example, an active water leak was noted in the industrial arts hallway outside classroom 91.

Damage To Roof Surface from Cleat Mark

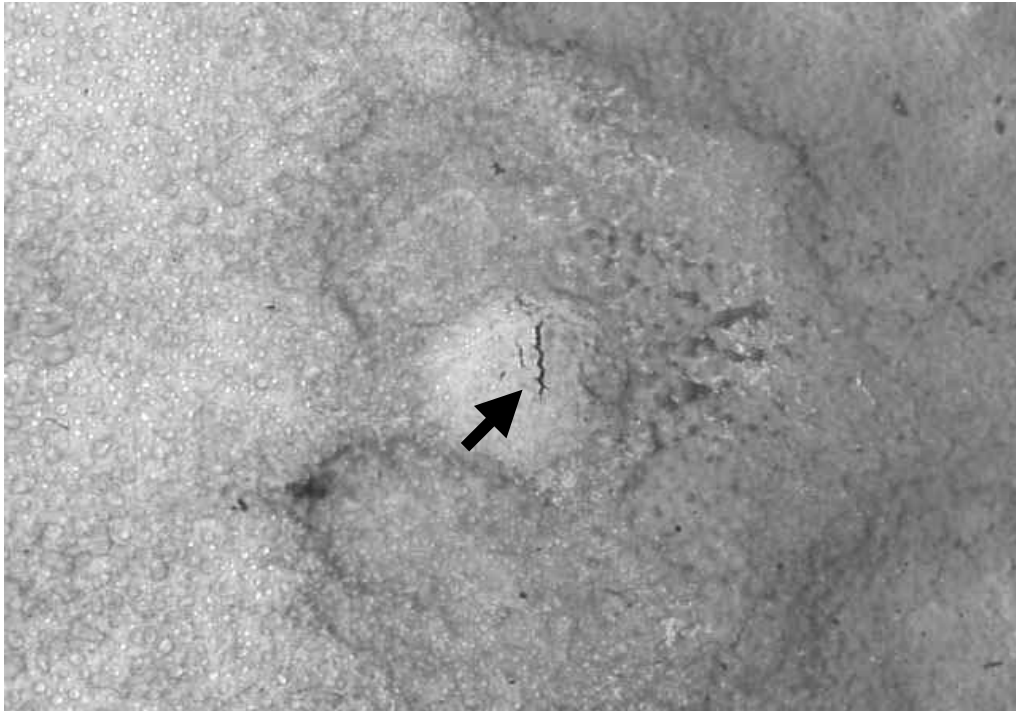
Picture 11

Typical Cracking Of Top Surface of Roof

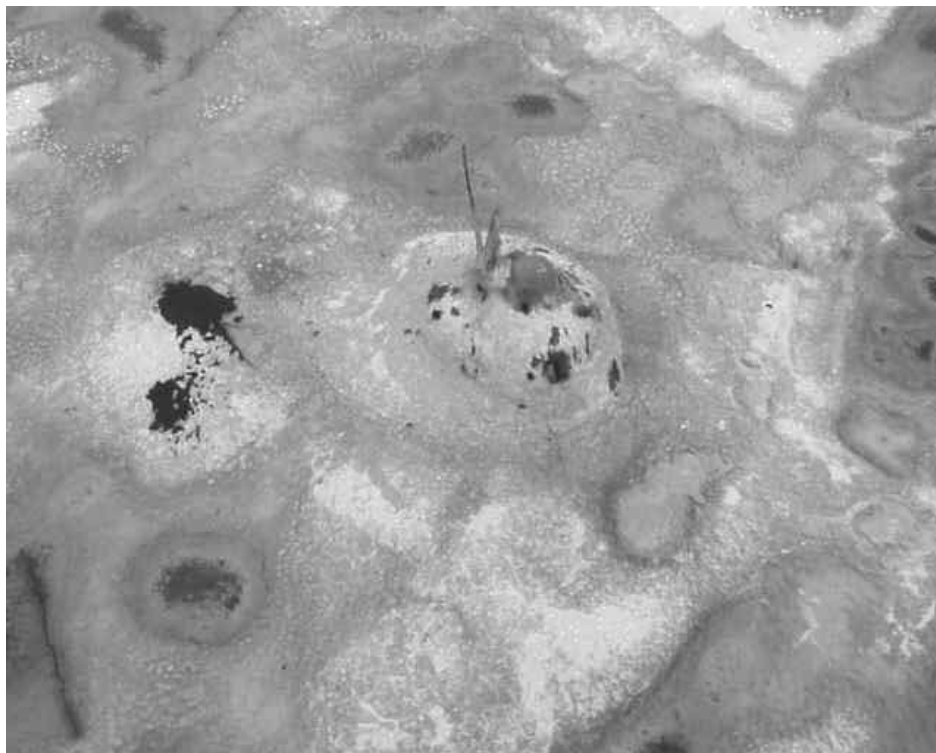
Picture 12

Puncture Damage on Roof Attributed to Birds

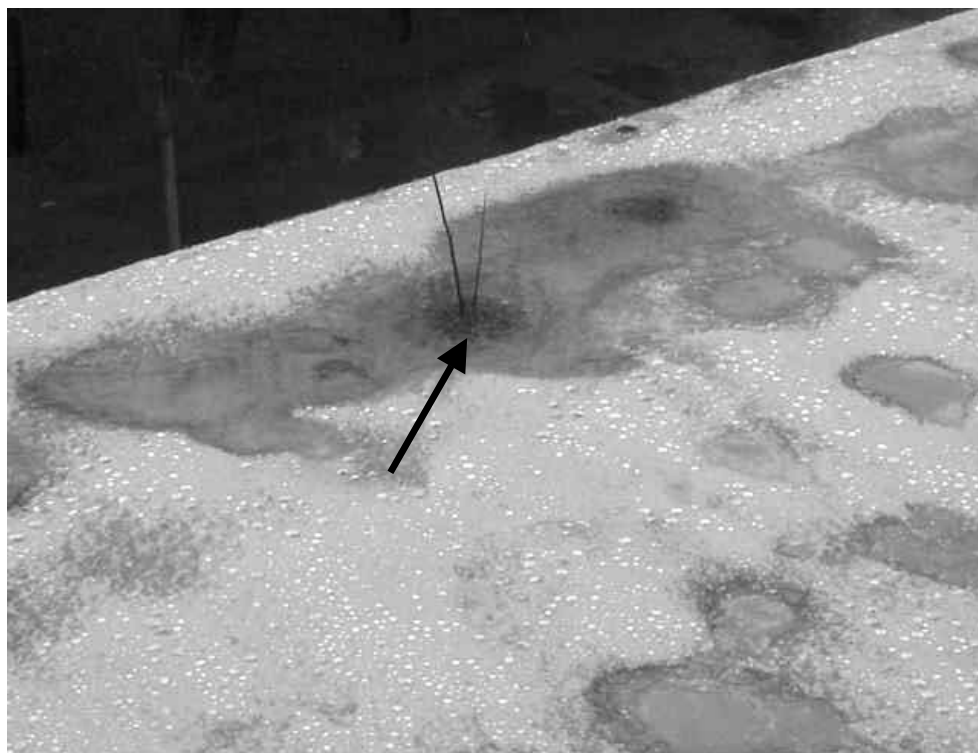
Picture 13

Plant Growing in Roof Crack

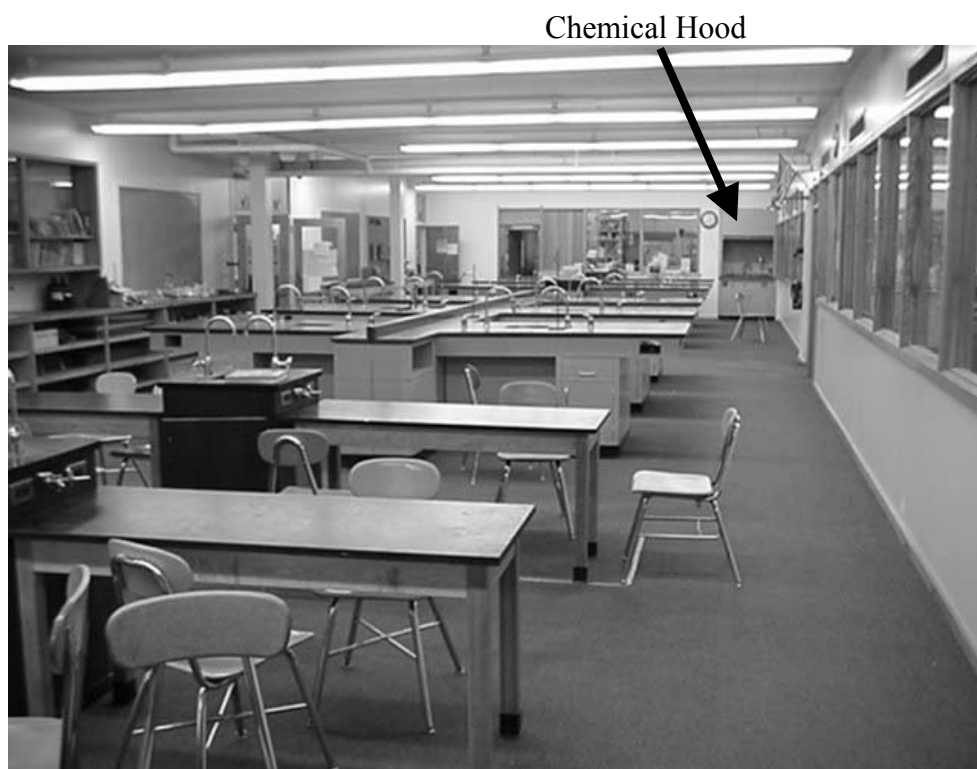
Picture 15

A number of other conditions that can potentially affect indoor air quality were noted during the assessment. The chemistry lab (room 108) has a carpeted floor. Located in the chemistry lab is a chemical hood (see Picture 15). Carpeting in laboratories is ***not recommended*** as a floor covering for several health and safety reasons. First, laboratory floors frequently become wet from spilled water, which if not dried, can serve as a mold growth medium. Of important note is the possibility of the carpet becoming contaminated by chemical spills. A carpet contaminated with chemicals may also serve as a reservoir for off-gassing of irritating substances. Once contaminated with chemicals, cleaning of the carpet is not a viable option. All contaminated surfaces of the carpet would be considered as a hazardous waste, requiring disposal in a manner consistent with Massachusetts hazardous waste laws and regulations. Of further concern is the interaction of spilled chemicals with the constituent materials of the carpet itself.

Frequently carpet consists of man-made materials (i.e., synthetic fibers). If contaminated with an organic solvent or strong acid, synthetic fiber may breakdown into its constituent chemicals, resulting in the release of hazardous materials. Some chemicals may react violently with synthetic materials resulting in fire. For these reasons a smooth, nonporous, nonflammable floor covering is preferred in science laboratories.

Carpeted Chemistry Lab, Note Chemical Hood on Rear Wall

2. Consider removing carpeting from science lab.
3. Examine the carpet in the 1982 addition for mold growth. If moldy, it is recommended to discard the carpet and disinfect the floor with an appropriate antimicrobial.

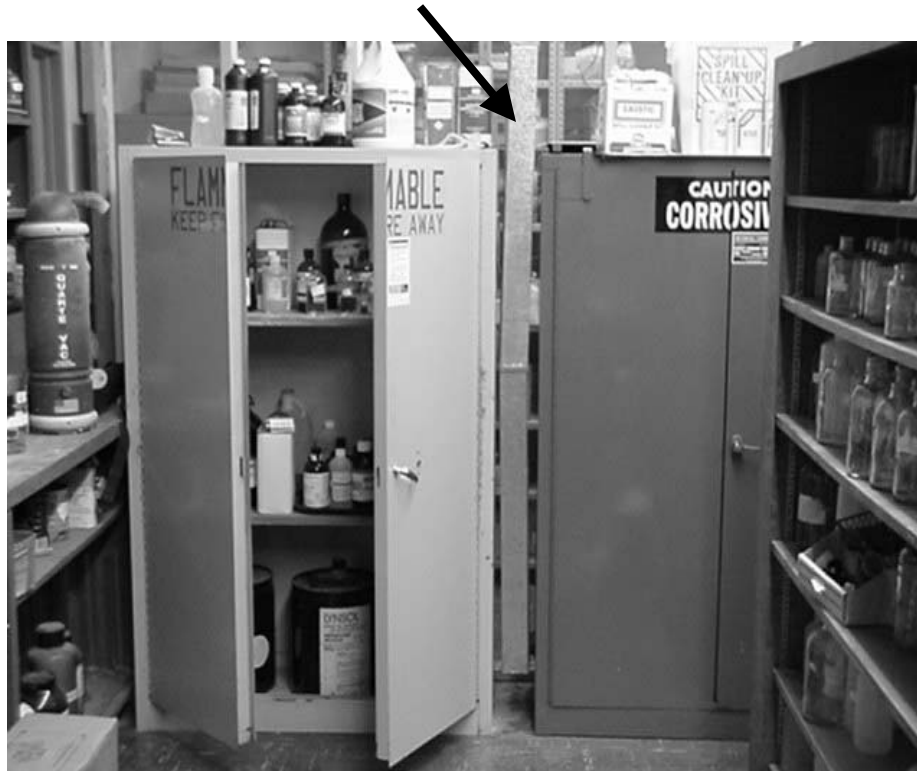
Picture 16

Also of note were the conditions that indicate improper storage of chemicals that may pose fire and safety hazards. Of concern is the condition of the flameproof cabinet in the chemical storeroom adjacent to room 108. This cabinet is connected to ductwork, which is installed to a rooftop exhaust vent. The National Fire Prevention Association (NFPA) does not require venting in flammable storage cabinets, however, if venting is done, it must be vented directly outdoors and in a manner not to compromise the specific performance of the cabinet (NFPA, 1996). If air backflow from outdoors into the cabinet through the venting occurs, off-gassing chemicals can be forced from the flammable storage cabinet into the storeroom. Proper design of exhaust vents should prevent air backflow into the cabinet. The installation of the exhaust vent ductwork has compromised the fire integrity of the cabinet. With this system deactivated, the ductwork itself can serve as a source of oxygen, which in the presence of a heat source can ignite a sufficient concentration of off-gassing flammable VOC vapor. In its present state, the flameproof cabinet may pose a fire hazard.

possible that off-gassing VOCs from the flameproof cabinet and evaporating acids from the acid cabinet can mix and react within the ductwork. Acids and VOCs should not be mixed in order to prevent unintended chemical reactions. It is also possible that when the exhaust vent motor is deactivated, off-gassing chemicals may penetrate into the chemical storeroom by the ductwork vent. Other problems noted in the science area which are or can be a fire and/or safety hazard include:

Exhaust Duct Shared by Flameproof Cabinet and Acid Storage Cabinet

1. Disconnect the flameproof storage cabinet from the duct and reseal the bung hole with the original bungs. If the original bungs cannot be located, contact the cabinet manufacturer to obtain replacements. Consider obtaining an acid resistant cabinet for the chemical storeroom.

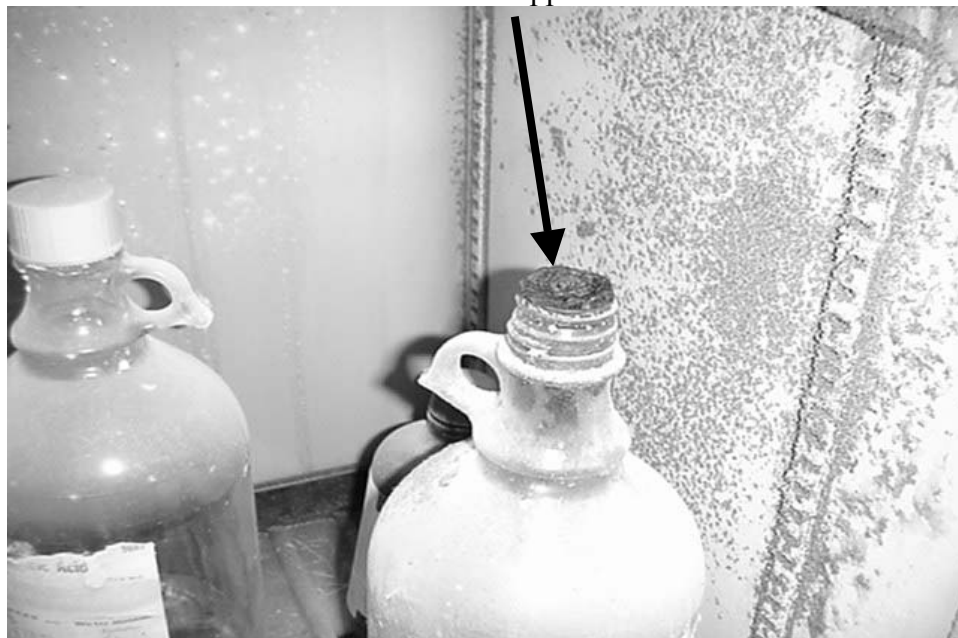
Picture 17

1. Shelves in the acid cabinet are heavily corroded from off gassing acids (see Pictures 17). Corrosive materials appear to have corroded the metal shelf supports, coating the shelf with oxidized metal. The corroding of the metal shelf supports can lead to the undermining of the structural integrity of the shelves. An accidental bump to the shelf could cause these shelves to fail, resulting in the breakage of the glass containers and subsequent opportunity for acid release into the chemical storage area. Under the observed condition of these shelves, it is highly recommended that stored containers be removed to prevent shelf failure. Acids should be stored in an acid resistant cabinet.

2. Bottles in the acid storage cabinets are coated with crystals, (see Pictures 18) indicating chronic off gassing of the container contents.
3. One bottle was stopped with a cork made of a rubber material, which has begun to deteriorate (see Picture 17), indicating an incompatible material with rubber is stored in this container.

**Corrosion on Metal Shelf Supports in Acid Storage Cabinet,
Note Collapsed Rubber Stopper in Bottle**

- Follow proper procedures for storing and securing hazardous materials.
16. Consider obtaining an acid resistant storage cabinet or reduce or eliminate acid use in chemistry area.

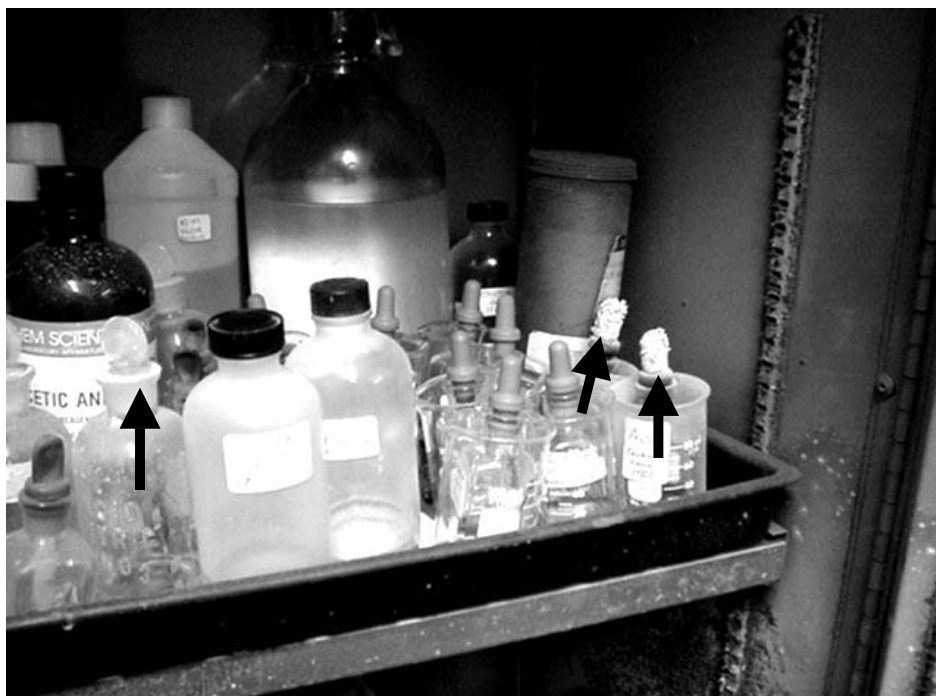
Picture 18

Bottles With Crystals on Caps in Acid Storage Cabinet

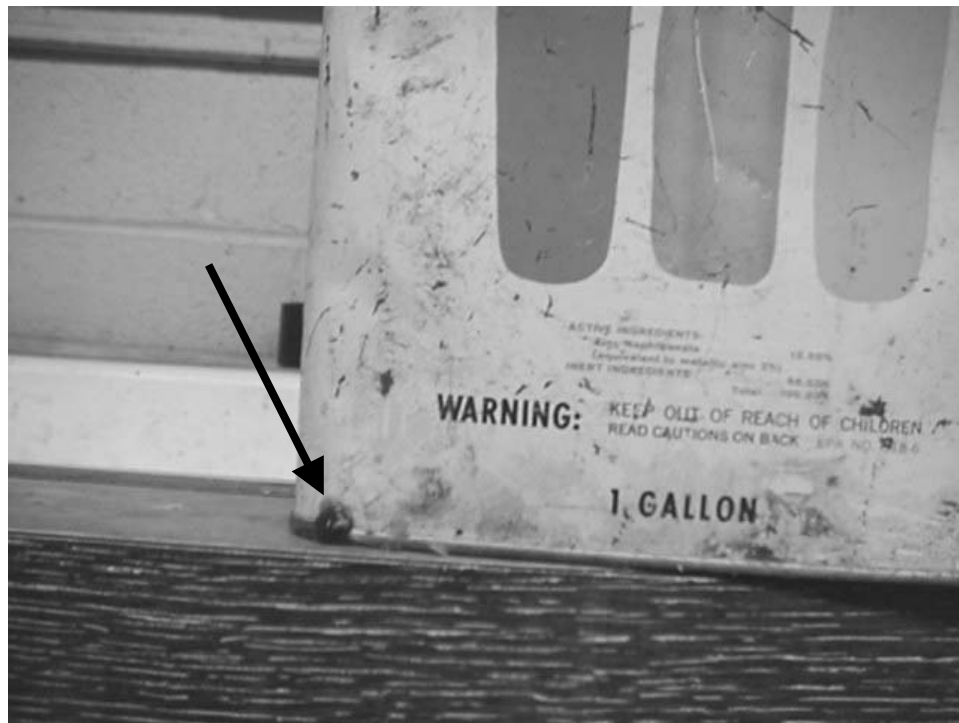
Picture 19

4. Flammable materials were stored on top of or outside of the flameproof cabinet
5. A container of Cuprinol[®] wood preservative appears to have a leak (see Picture 19).

Possibly Leaking Container of Cuprinol®

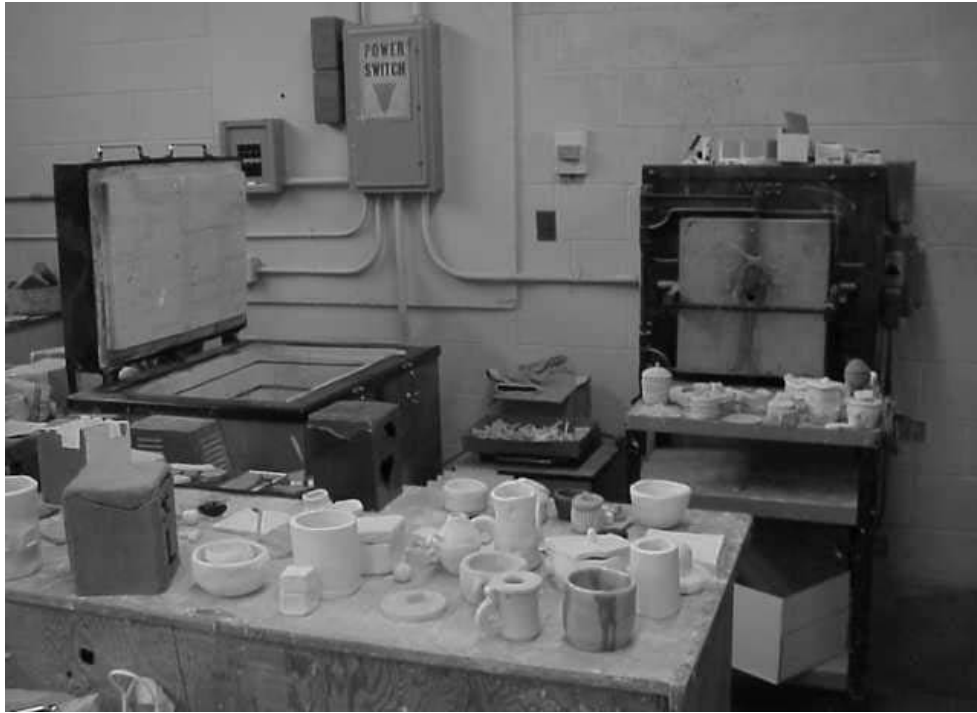
Picture 20

The art room (room 87) has two unvented pottery kilns (see Picture 20). Pottery kilns can produce carbon monoxide and sulfur dioxide, which can cause respiratory symptoms in exposed individuals (McCann, M., 1985). Local dedicated exhaust ventilation is necessary to remove kiln-generated pollutants from the indoor environment. The art room also has a number of flammable materials stored on an open shelf (see Picture 21). Flammable materials should be stored in a flameproof cabinet that meets the specifications of the NFPA (NFPA, 1996).

Unvented Pottery Kilns in Art Room

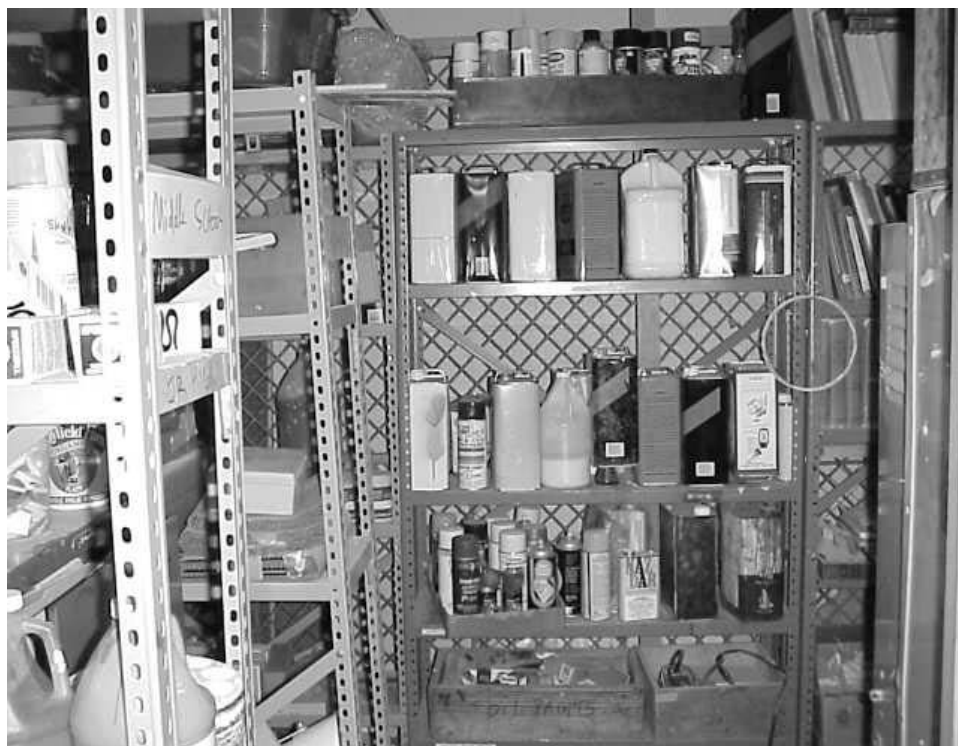
Picture 21

Flammable Materials Stored In Art Room

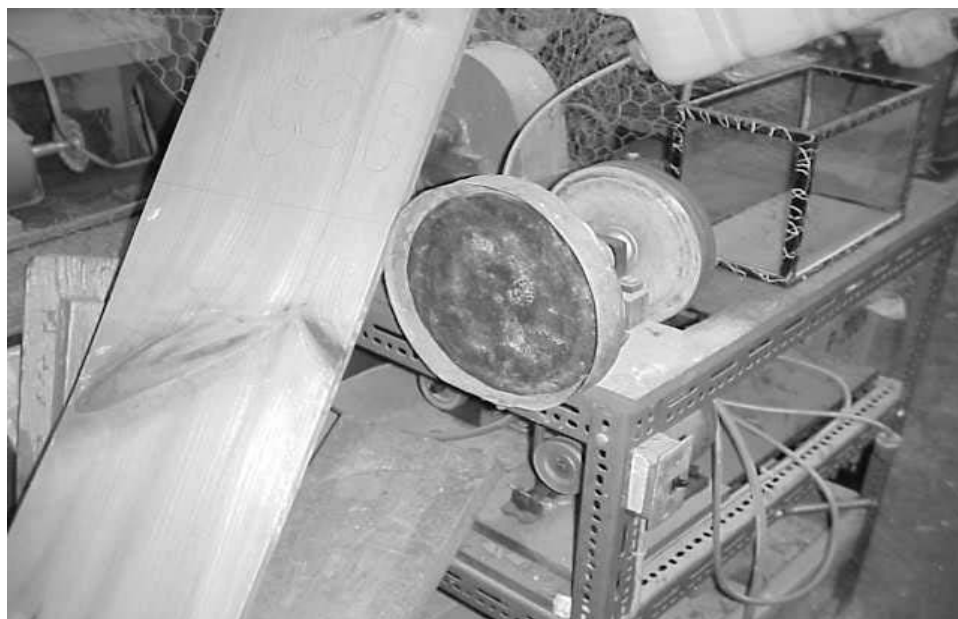
Picture 22

Unvented Grinding Wheel in Art Room

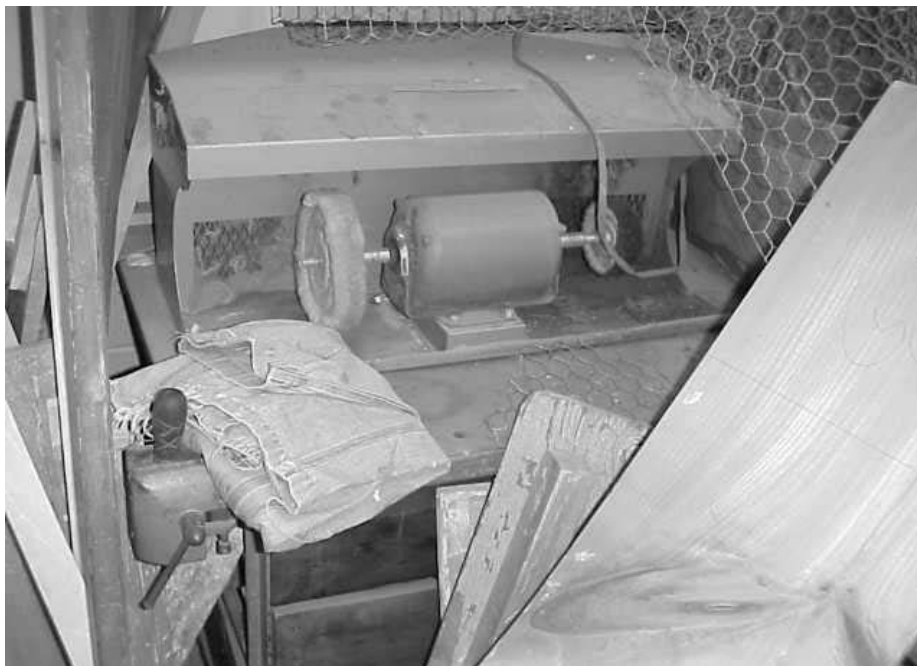
Picture 23

Unvented Grinding Wheel in Art Room

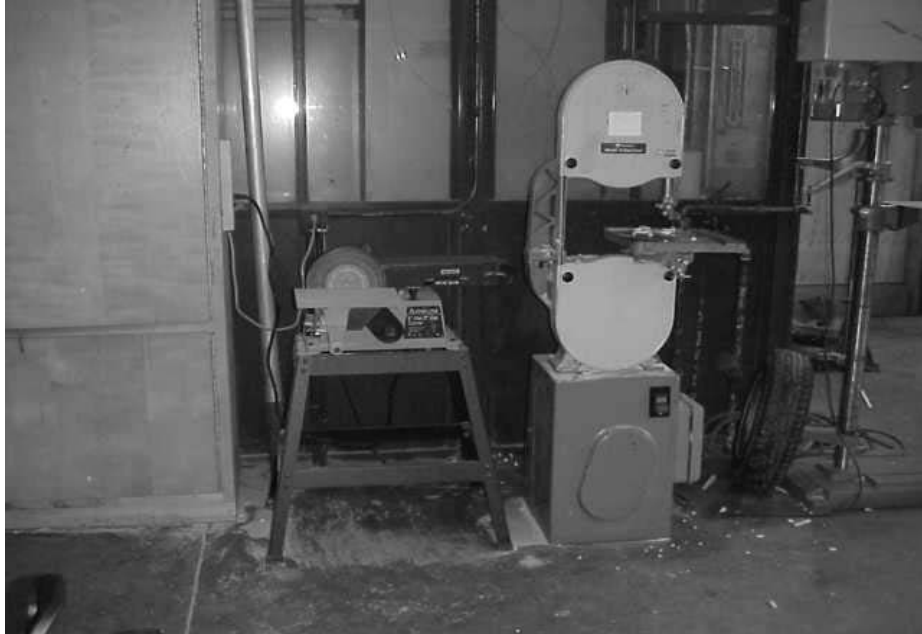
Picture 24

Unvented Grinding Wheel and Saw In Automotive/Small Engine Shop

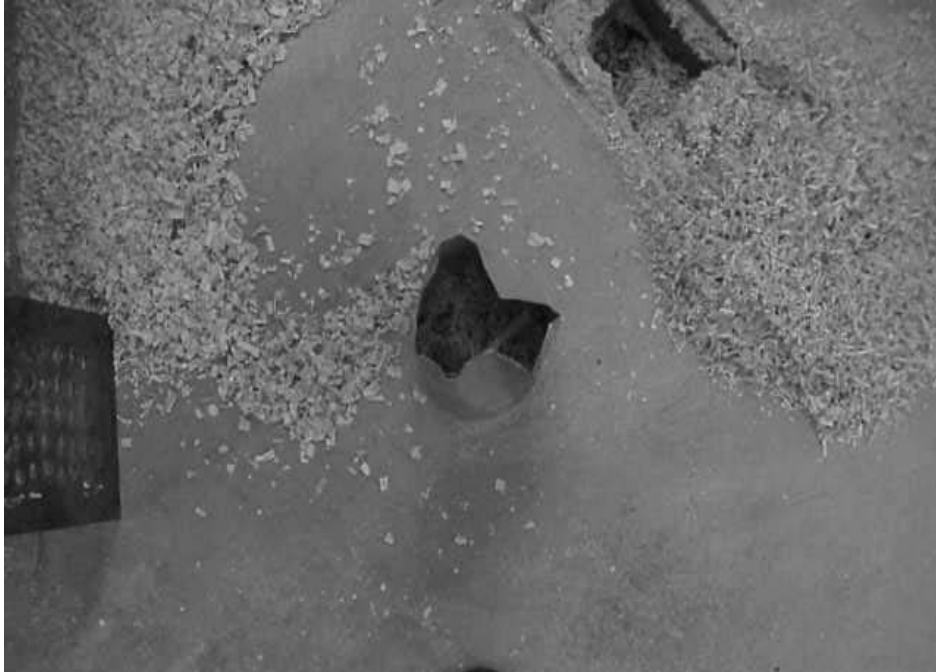
Picture 26

Below Floor Dust Collection Vents Clogged with Sawdust

28. Restore wood dust collection system to proper function. Clean/replace filter for wood dust collector as recommended by the manufacturer or more frequently if needed.

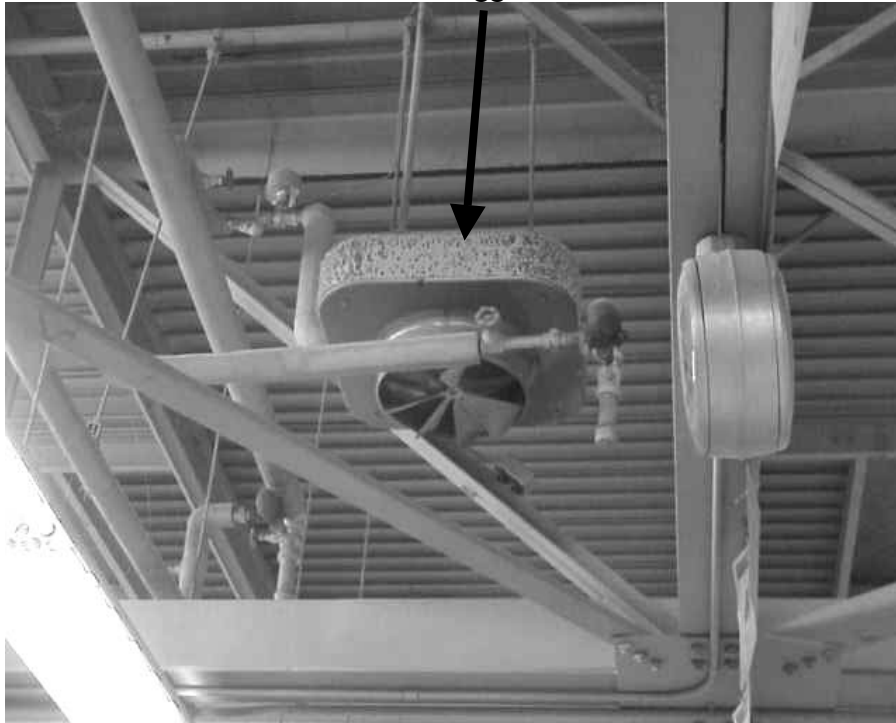
Picture 27

Saw Dust Clogged Ceiling Mounted Heater

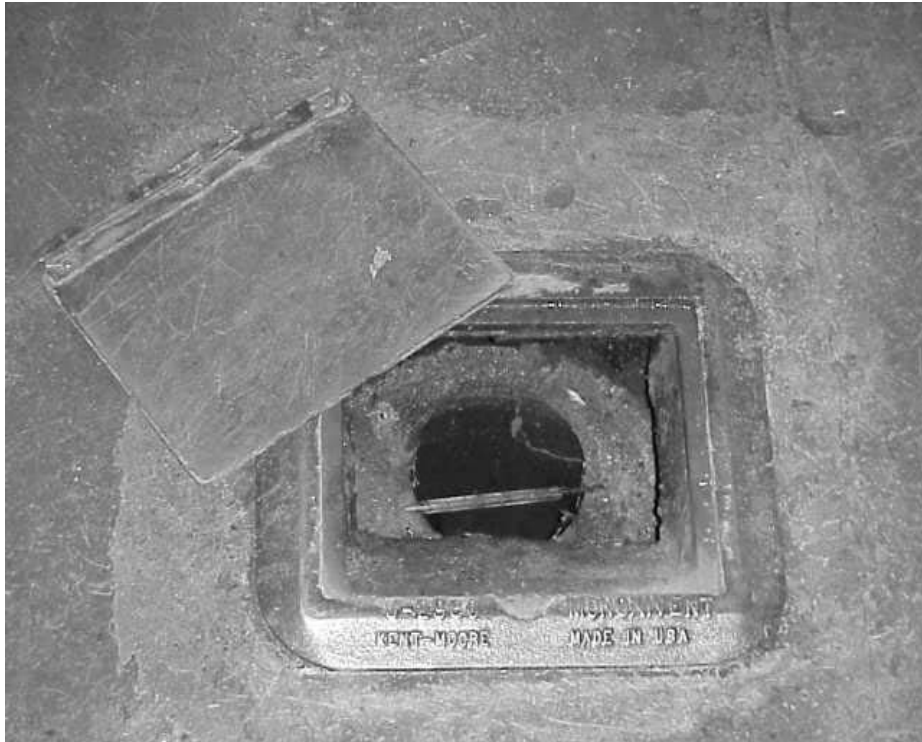
Picture 29

Vehicle Exhaust Vent In Room 97

5. Render the vehicle exhaust vent in room 97 airtight.
6. Survey classrooms for univent function to ascertain if an adequate air supply exists for each room and make univent repairs as needed. Check fresh air intakes for repair and increase the percentage of fresh air intake if necessary.

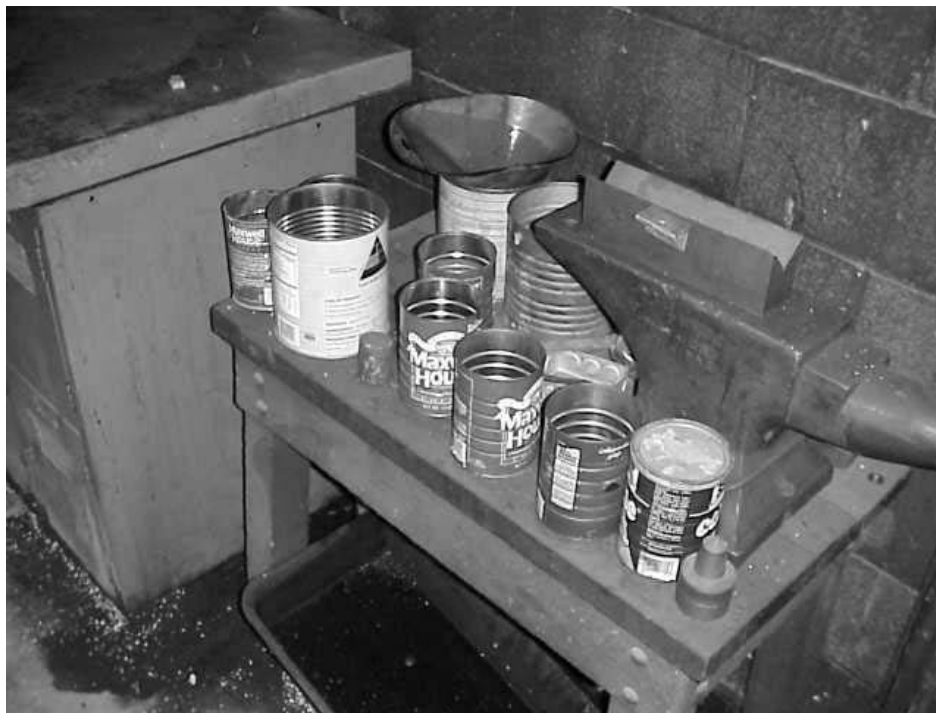
Picture 30

Oil odors were also noted by BEHA staff in the automotive/small engine shop. Open containers of motor oil and absorbent material (see Pictures 30 and 31) on the floor were noted in this shop. The presence of absorbent material is usually indicative of past oil spills. Oil absorbent materials should be removed once applied. Such materials can be a continuing source of odors and should be removed after use. Oil vapor can be irritating to the eyes, nose and throat.

Open Containers of Motor Oil

21. Remove oil contaminated absorbent materials on the floor of the automotive/small engine shop. Store used oil in a sealed container.
 22. Repair/replace pencil sharpeners to avoid the aerosolization of wood/pencil shavings.

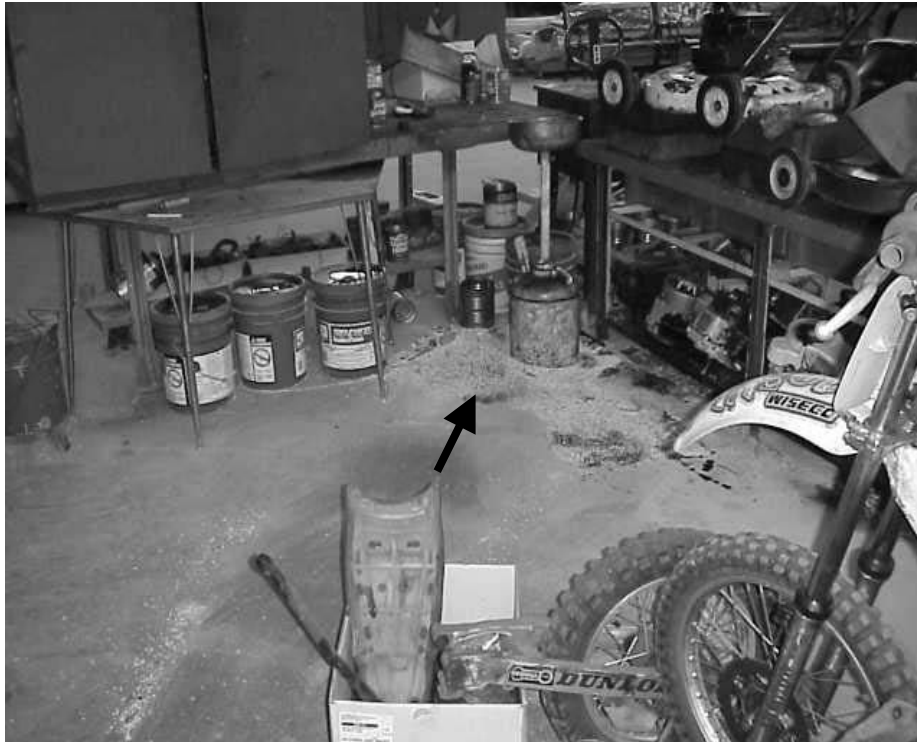
Picture 31

Absorbent Material on the Floor of the Automotive/Small Engine Shop

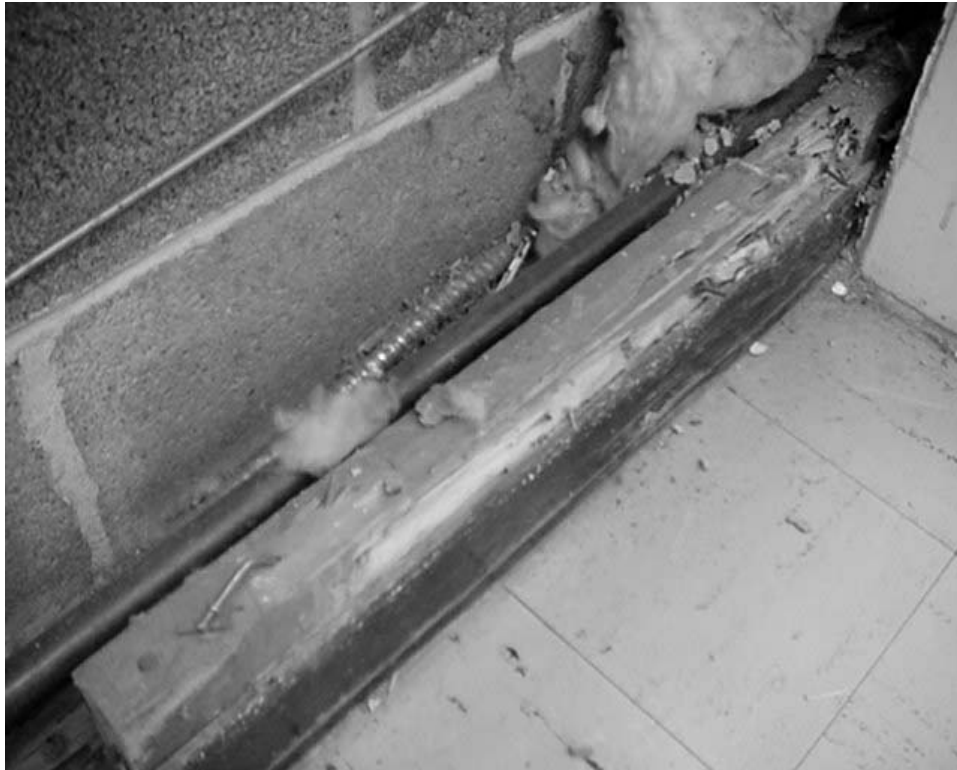
Picture 32

The building shows signs of termite infestation. Termite damaged wood was noted in the east side of the main building (see Pictures 32 and 33). In an effort to treat the termites, maintenance staff applied a pyrethroid pesticide to the floor of the room. This pesticide was removed upon return on April 26, 2000 by BEHA staff. Termite infestation results from penetration through holes in the exterior of a building (see Picture 34) at areas where wood is chronically damp. A three-step approach is necessary to eliminate pest infestation:

Termite Damaged Wood Inside Wall Cavity beneath Windows

29. Use IPM to remove termites from the building. A copy of the IPM recommendations is included with this report as Appendix A (MDFA, unknown). Activities that can be used to eliminate pest infestation may include the following activities.

- i) Consult a licensed pesticide applicator on the most appropriate method to end the termite infestation.
 - ii) Once termite colony is eliminated, identify the source of moisture wetting wood and repair.

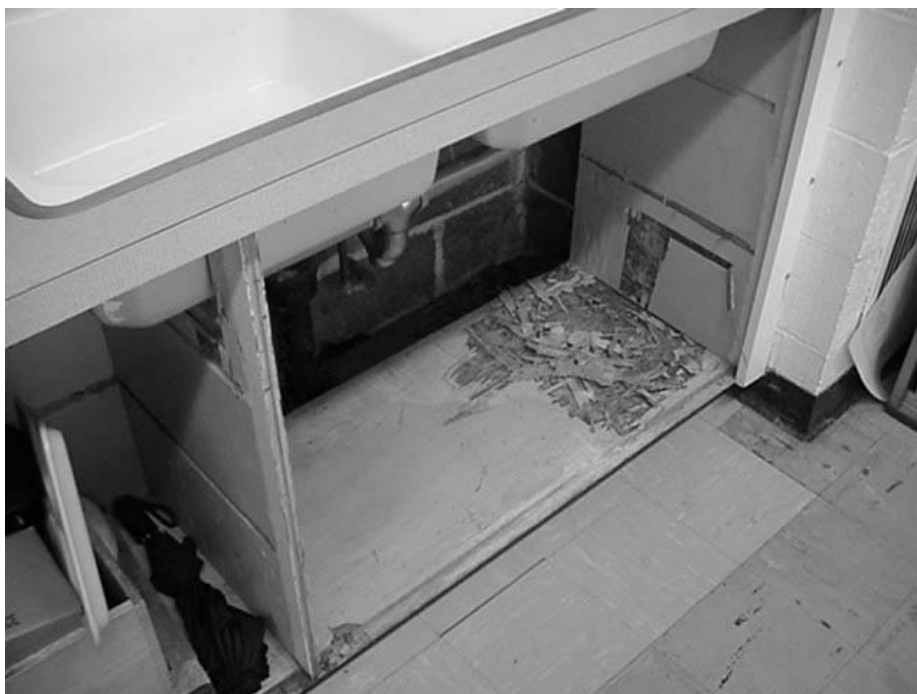
Picture 33

Termite Damage Beneath Classroom Sink

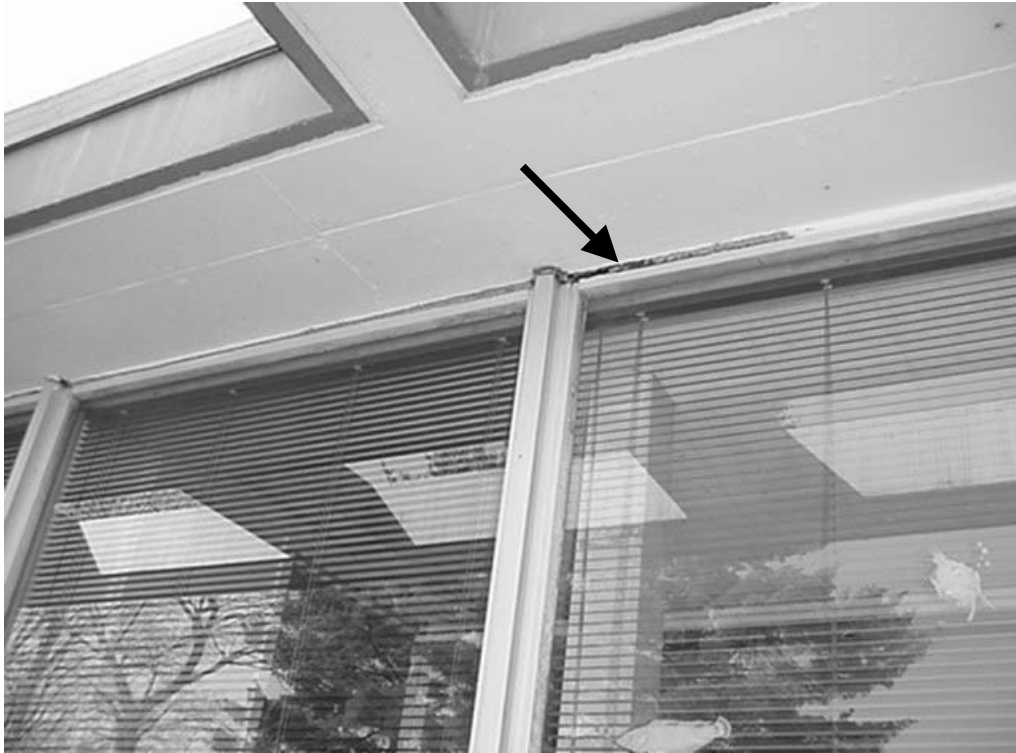
Picture 34

Seam In Window Frame near Classroom with Termite Damage
